Monitoring of landslides in the Brda river valley in Koronowo (Polish Lowlands)

Abstract The paper discusses landslides investigated in a Brda river valley in the region of the town Koronowo near Bydgoszcz (Kujawsko-Pomorskie Voivodeship) in the Polish Lowlands. Due to morphologic and geologic setting the area is prone to slope instability. Out of 32 identified landslides, 9 were selected for detailed examination. To register a nature and rate of failures a complex monitoring system was installed on slopes where the selected landslides resulted in damages to municipal infrastructure. The system was facilitated with inclinometers and piezometers, supported by a network of GPS-RTK geodetic benchmarks as well as with a recording station. The performed examination revealed that the most unfavourable arrangement of the layers is, when under a non-cohesive soil lies a cohesive impermeable layer. The landslides are rather shallow ones (except for two incidents) with slow rate of displacement. The landslide-triggering factor is water originating from precipitation and snow melting. Influence of water was especially significant in early spring 2011, due to

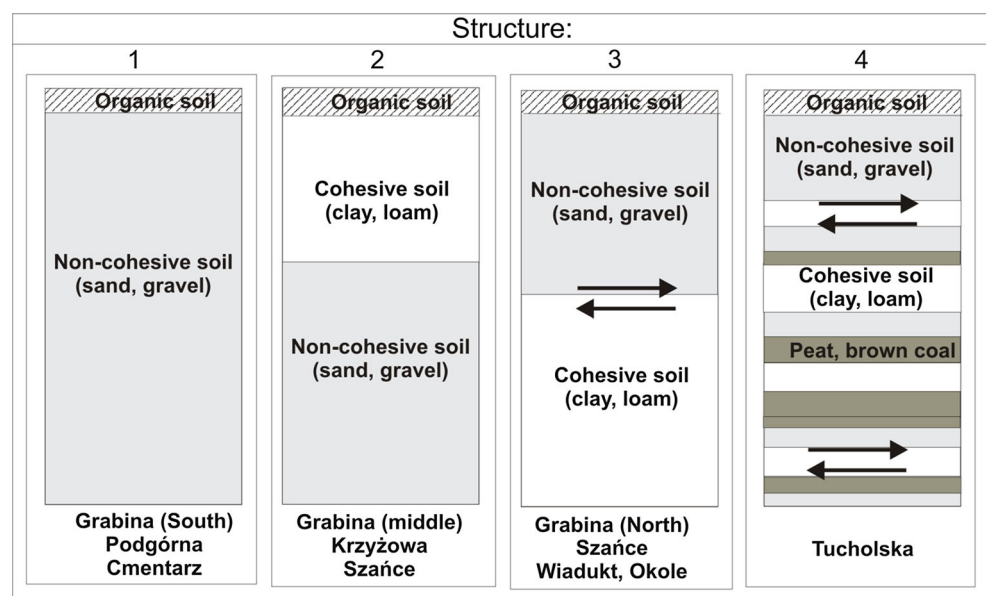
Fig. 2 Division of the soil massifs composing the slopes into structures

In the selected nine test slopes, 36 boreholes were carried out. A detailed geological mapping of borehole cores made it possible to divide the soil masses composing these slopes into four structures (Fig. 2). The soil mass of the first structure builds the slopes C, B, P and the southern part of G, where fluvioglacial variegated sands and gravels occur. The second structure (landslide K, the central part of G, partially SZ, the toe of O) is formed of a several-meters-thick subsurface layer of cohesive soil (clay, loam), underlain by non-cohesive sands and gravels. The structure third is composed of a several-meters-thick subsurface layer of non-cohesive soil, underlain by plastic clays and loams (northern part of G, O, partially W and SZ). Only the landslide T is composed of the mass classified as structure four in which layers of different soils are visible, such as sand, clay, peat, and brown coal.

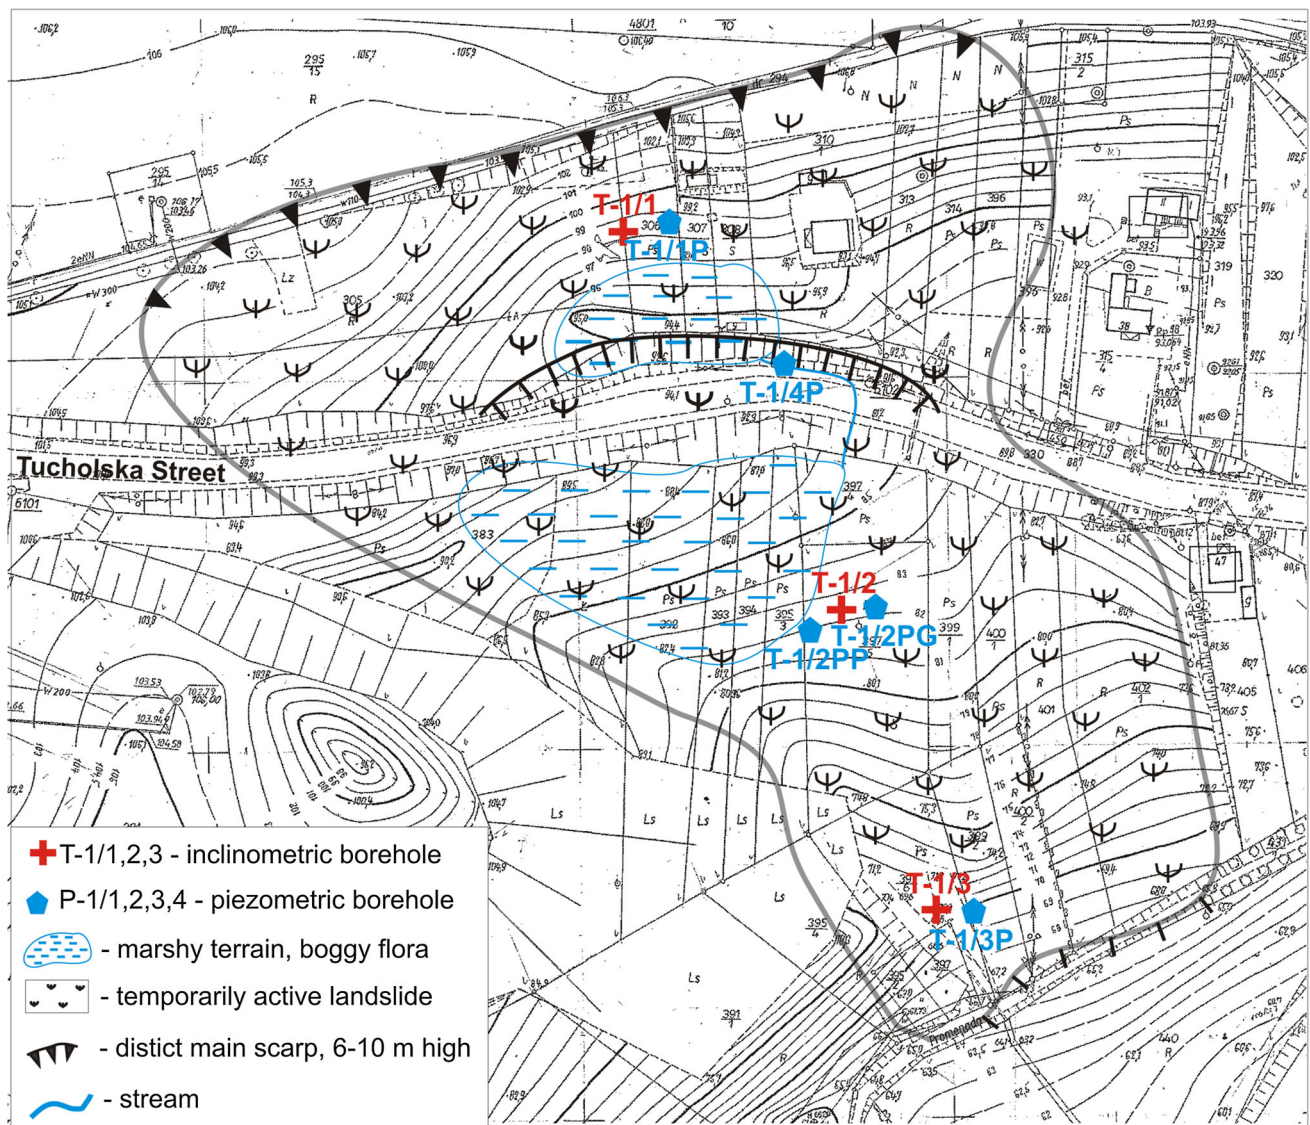
Fig. 3 Map of the landslide T indicating the location of inclinometric and piezometric boreholes

A monitoring system was constructed to measure both the effects and the causes of mass movements. From among 36 boreholes, inclinometric casings were installed in 23, and open-pipe piezometers in 13. The effects, i.e. displacements, were systematically measured in inclinometric boreholes once a month, on average. Moreover, geodetic measurements of 48 benchmarks were carried out twice a year, in spring and autumn. Owing to difference in accuracy of these two kinds of measurements, it is practically impossible to compare their results with any accuracy. Geodetic measurements are useful, however, in detecting the zones of higher deformation activity in places where inclinometric boreholes are not installed and in comparing deformation activity in specific landslide zones. Nevertheless, the principal information about landslide movements was provided by the results of inclinometric measurements. Inclinometric boreholes were made in different zones of the landslide, i.e. near its main scarp, in the middle, and in the toe. They were usually accompanied by piezometric boreholes for the investigation of the relationship between displacement and the groundwater table. For example, the distribution of boreholes in the slope T is presented in Fig. 3.

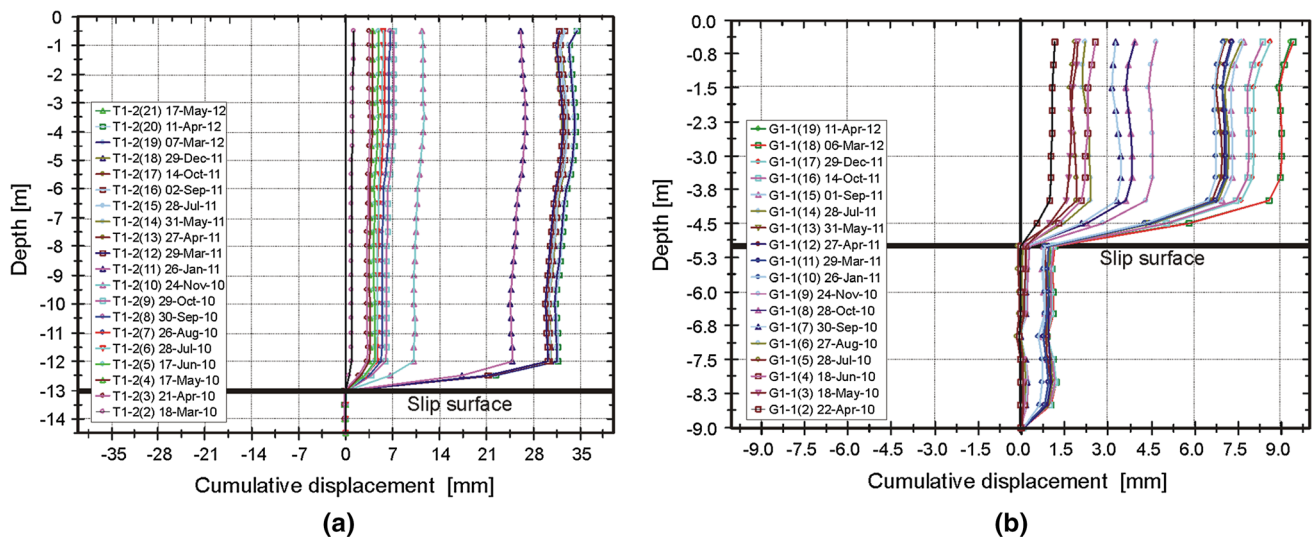
Fig. 4 Example inclinometric displacements with slip surfaces marked: **a** landslide T, borehole T1/2; **b** landslide G, borehole G-1/1

There are two types of inclinometric curves, showing significantly different behaviour of the slopes. Results from the boreholes proved the stability of some slopes, as the measured displacements were practically within the range of the accuracy of the measuring device. The landslides C, K, P, and the southern and middle parts of G belong to this group. It could be thus concluded that these slopes were stable during the measurement period, although some signs of former deformations are evident when the morphology of the slopes is inspected. In contrast, the boreholes in T, G (north) and SZ reveal mass movement. Figure 4 shows example results from two boreholes.

The depth of the landslides is generally small and ranges from 1.5–2.5 to 5 m (Fig. 4b). One exception is the landslide T. A slip surface was identified at the depth of 15 m in its upper part, at 13 m in the middle part (Fig. 4a), and at ca.

6 m in the toe region. The average displacement rate amounted to a few mm/year, and according to Varnes (1978) classification, a movement rate below 60 mm/year is qualified as extremely low. A relatively large displacement increment can be observed in the figures for the period between November 2010 and March 2011. Indeed, this period could be considered as critical, since catastrophic movement occurred in two cases, namely in the landslides W and O. The displacement of the landslide W was at least 10 m, which resulted in the damage of an old narrow-gauge railway embankment in the nearest vicinity of a bridge over the Brda river. The first cracks in the neighbourhood of the main scarp appeared in February 2011, followed by a large and rapid movement in March. Figure 5 shows the main scarp of this landslide. Similar huge deformations occurred during the same period in the landslide O.

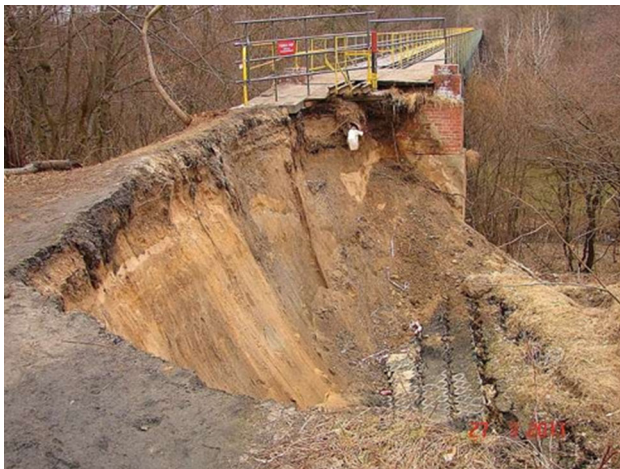
Fig. 5 Main scarp of the landslide W in March 2011

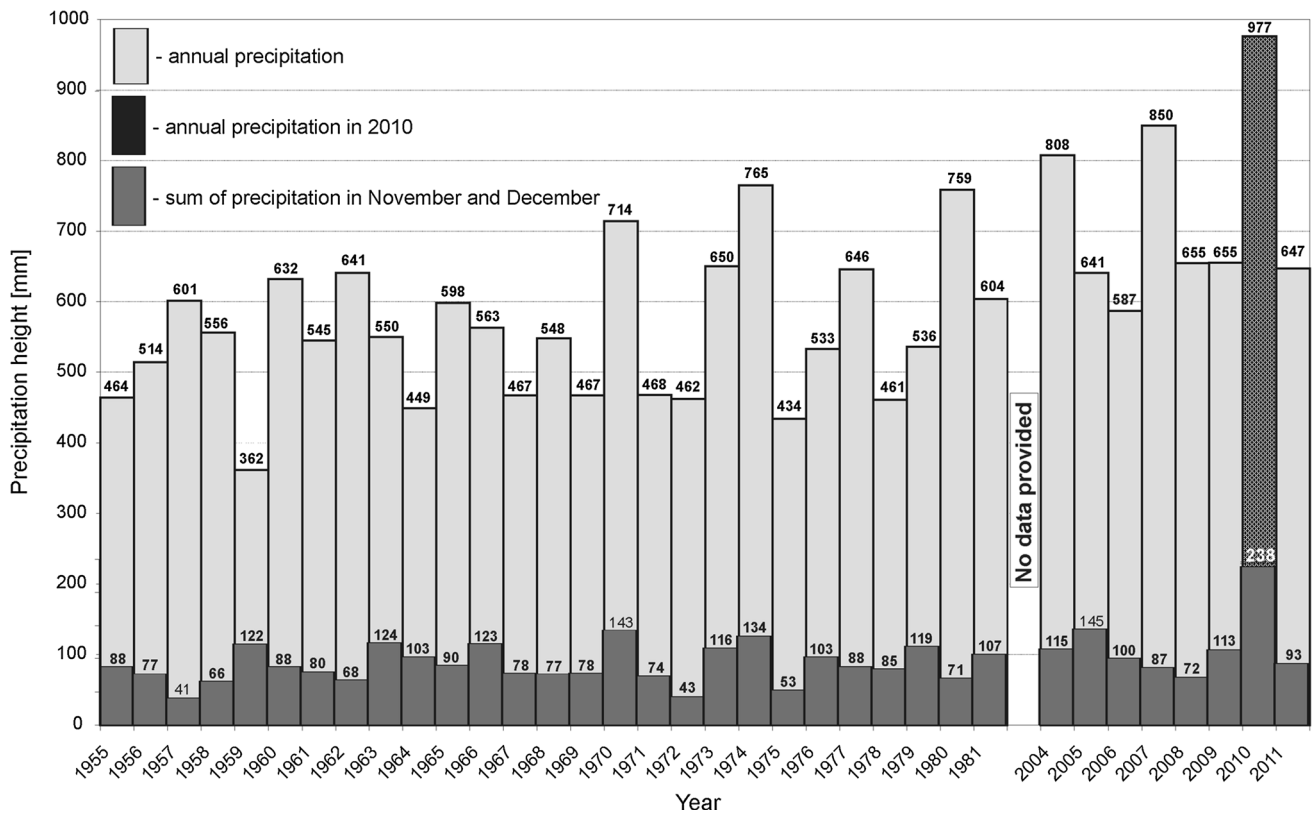
Fig. 6 Annual precipitation and sums of precipitation in November and December in the years 1955–1981 and 2004–2011

An automatic meteorological station was installed, measuring continuously precipitation and air temperature. Moreover, the annual and monthly precipitation data for the years 1955–1981 and 2004–2012 at a station located in Koronowo were taken into account. The distribution of the average annual precipitation and the sums of precipitation in November and December are shown in Fig. 6.

As shown in Fig. 6, the annual precipitation in 2010 and the sum of precipitation in November and December 2010 were, respectively, 134 and 255 % of the corresponding averages for the last 34 years recorded. However, the influence of precipitation on slope behaviour appears to be a complex question, as the response of the slopes does not depend on precipitation only. The processes of evaporation and transpiration, which depend on the season of the year, should be taken into account, as well. According to Lambor (1971), the sum of annual evaporation and transpiration in

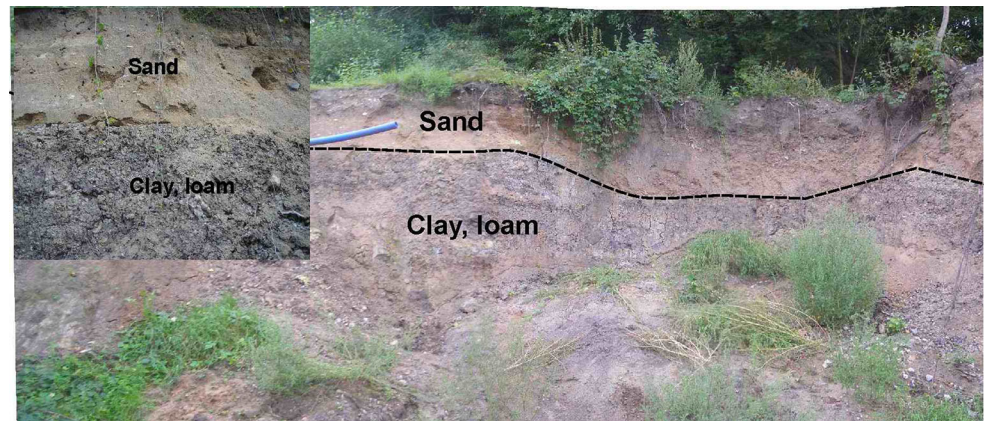
Fig. 7 Main scarp of the landslide W with a marked division between soil layers

In general, it is possible to distinguish between passive and active factors influencing landslide development. The passive ones include slope morphology (inclination, aspect, elevation), vegetation cover, hydrological conditions, land use, and the lithology of the slope soil. In Koronowo, the influence of the above factors is not noticeable. One important exception is lithology. As explained in the preceding chapters, the arrangement of soil layers has a dominant influence on slope behaviour. An impermeable layer below highly permeable sand cover (structure 3; see Fig. 2) creates particularly favourable conditions for landslide development. Such an arrangement, observed in the main scarp outcrop, is presented as an example in

Fig. 7. A clear line dividing sand and clay is marked in the figure. In fact, a displacement of many meters was observed in this slope (W). Conditions favourable to sliding are also the effect of the presence of weak soils, such as peat and mud (structure 4—landslide T). The lithology of the soil massif explains the fact that most of the landslides are located on the western bank of the Brda river, where structures 3 and 4 dominate.

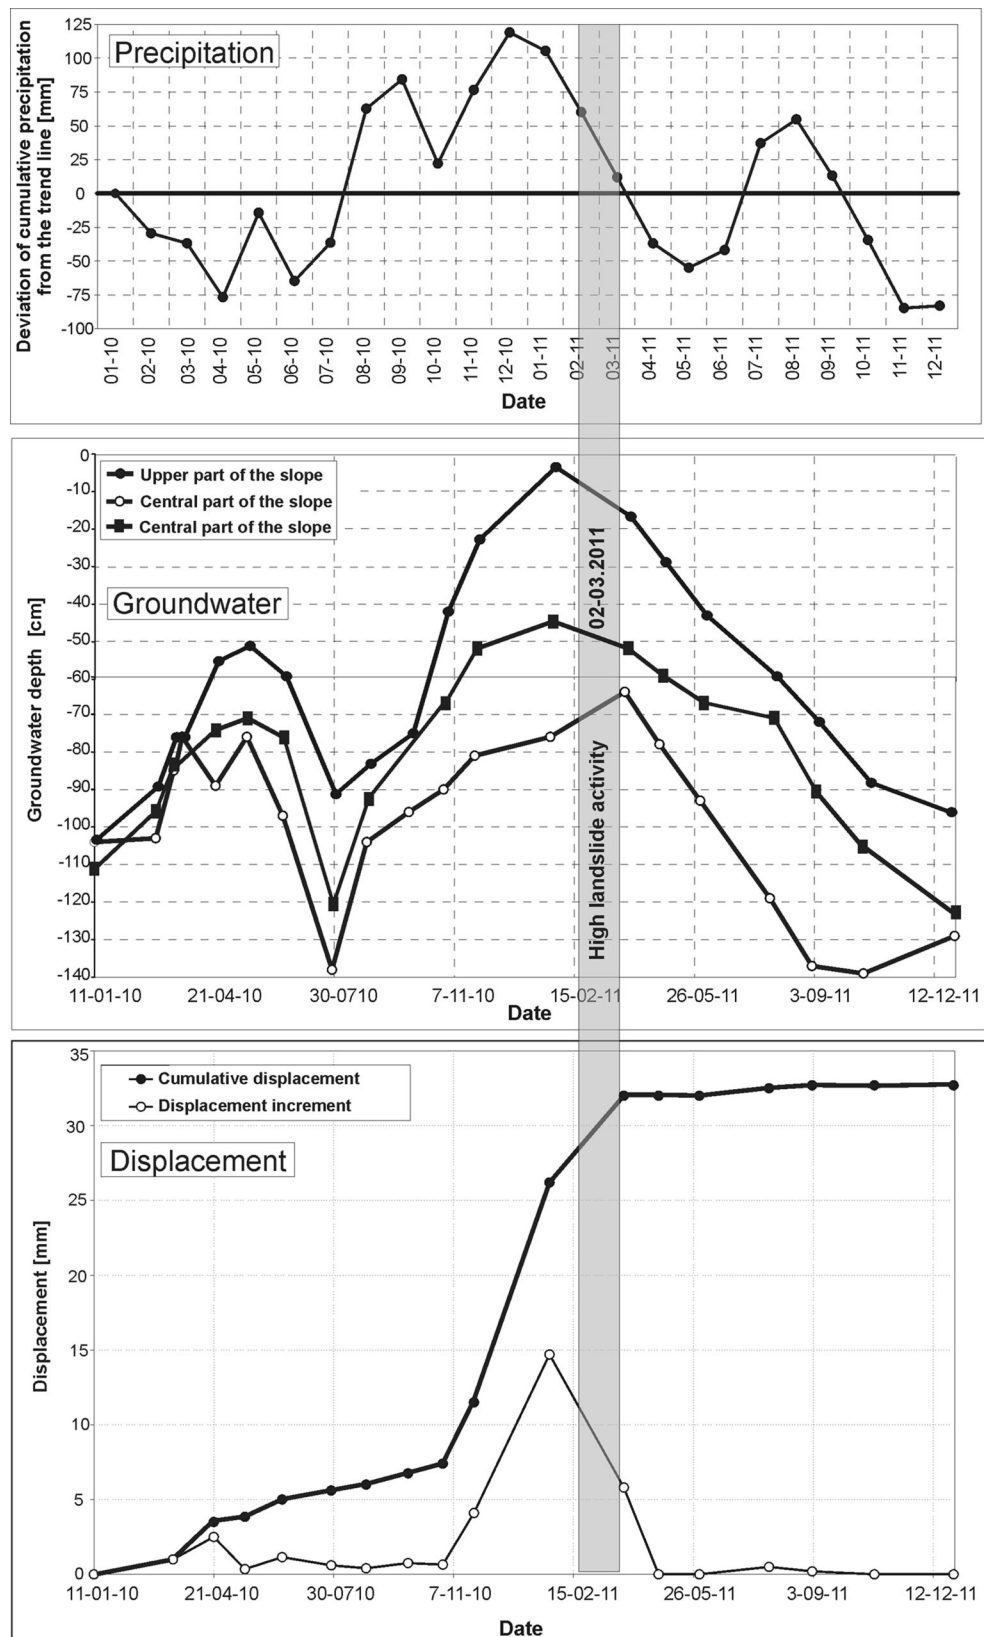
Fig. 8 Selected diagrams of precipitation, groundwater level, and displacement

beginning of 2011, as shown in Fig. 6. Figure 8 presents three charts: the precipitation pattern, the ground water level (for the landslide T), and displacement curves (for the borehole T-1/2).

It is seen that the displacement rate increased significantly as a consequence of unfavourable conditions of precipitation and GWL, yet the delay between their peak between December 2010 and January 2011 and the landslides of February and March 2011 requires an explanation. A detailed analysis of the curves in Fig. 9 reveals the cause of this delay.

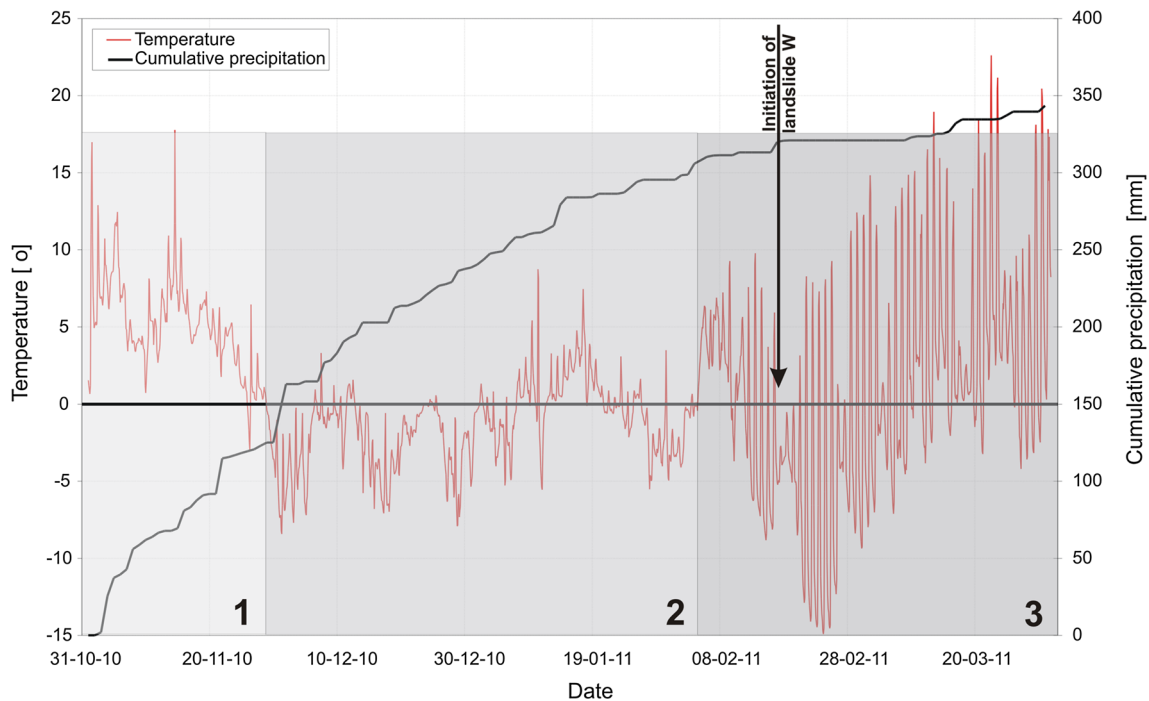
Fig. 9 Temperature and cumulative precipitation curves for the period preceding the initiation of landslides

pressure increase and the weakening of the clay layer (the shear strength parameters of clay composing the slip surface in the limit equilibrium state were very low, i.e. cohesion $c = 10$ kPa and the angle of internal friction $\Phi = 6^\circ$). This triggered the landslides W and O as well as accelerated the displacements on other slopes (Fig. 9).
